Flood Control Project Maintenance
2015 Structure Summary Report
Overall Unit and Item Ratings

DWR Sutter Maintenance Yard

Butte Slough Drainage Structure

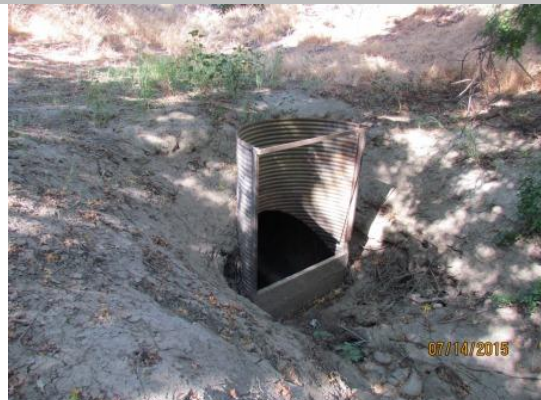
Photo 3 of 5 : ST_2015_NA0060_38_1_20150715_00007.jpg

Butte Slough Drainage structure on the land side.

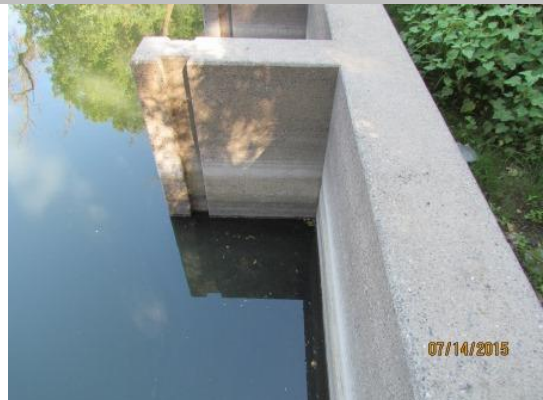
Photo 3 of 4 : ST_2015_NA0060_42_1_20150715_00007.jpg

View of the stop log slots on the water side.

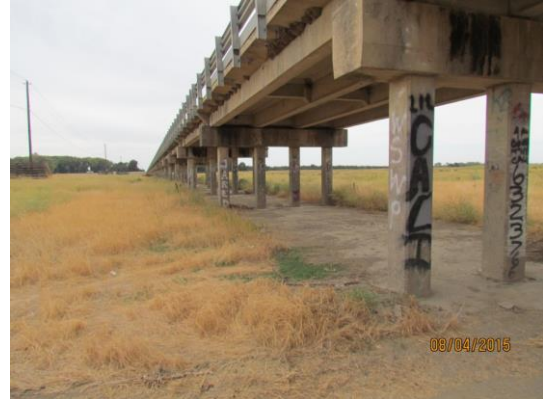
Photo 1 of 1 : x_2015_NA0060_55_2_20150820_00014.jpg

View of the vegetation found in the weir from the right bank of the channel.

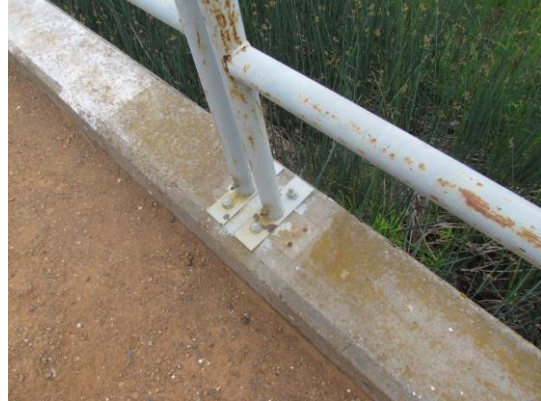
Photo 1 of 1 : ST_2015_NA0060_9_23_20150728_00012.jpg

View of handrails with loose bolts.

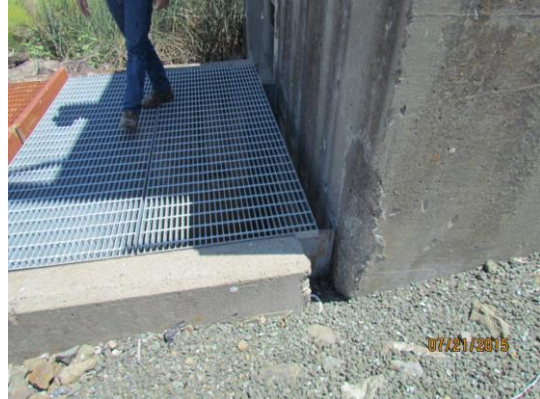
Photo 2 of 2 : ST_2015_NA0060_17_3_20150810_00020.jpg

LM Start	0.00	Rating **	M	Issue No.	3
LM End	0.00	Issue Type +	Ma	Location *	
Category	Pump Stations			GPS Latitude/Longitude	
				Start	End
Item	Plant Building			39.142300 °	39.142300 °
				-122.902350 °	-122.902350 °
DWR ID	DWR_NA0060_17_t_2012_3				
Action/Comments					
Inspector Comments: The plant building was in good structural condition with no major cracks that could threaten the integrity of the building. However, the adjacent structure had some differential settlement.

View of the settlement next to the pumping plant.

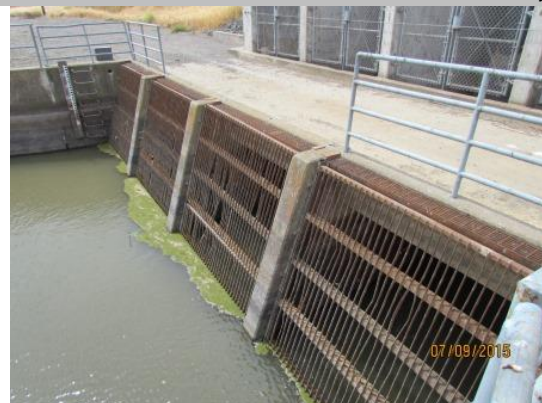
Photo 2 of 2 : ST_2015_NA0060_21_5_20150717_00023.jpg

View of the missing railing at the inlet grates.

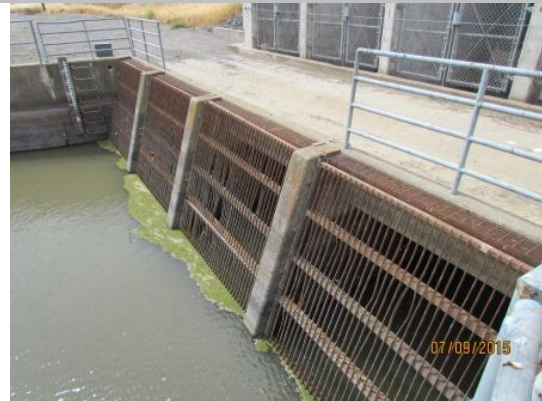
Photo 1 of 1 : ST_2015_NA0060_21_13_20150717_00022.jpg

Photo shows properly maintained trash racks. Note the missing guard rail for fall protection - replace in kind.

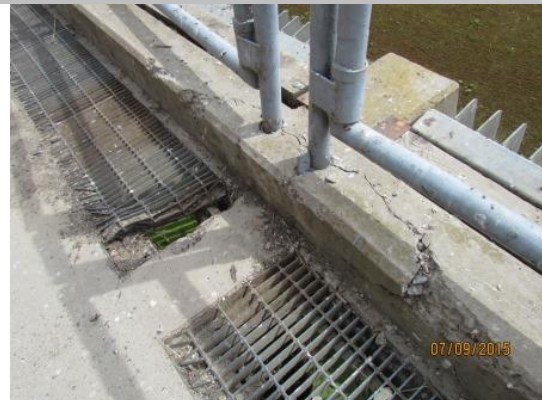
Photo 1 of 2 : ST_2015_NA0060_22_3_20150720_00016.jpg

View of the concrete spalling and damaged grate.

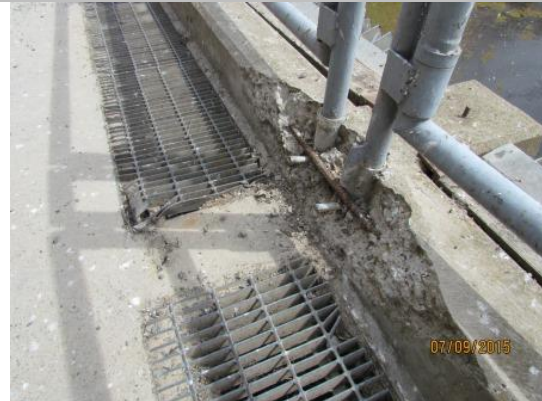
Photo 2 of 2 : ST_2015_NA0060_22_3_20150720_00017.jpg

View of the exposed rebar.

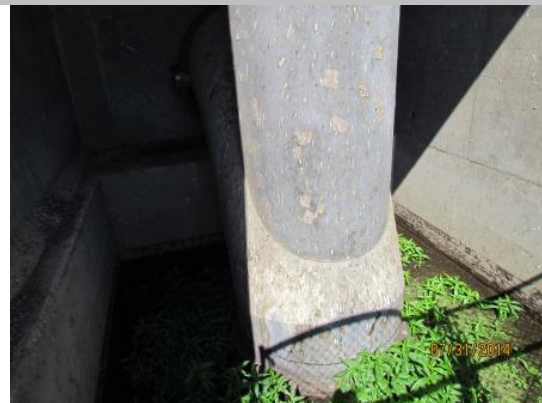
Photo 1 of 1 : ST_2015_NA0060_22_12_20150709_00008.jpg

Photo shows one sump with vegetation present.

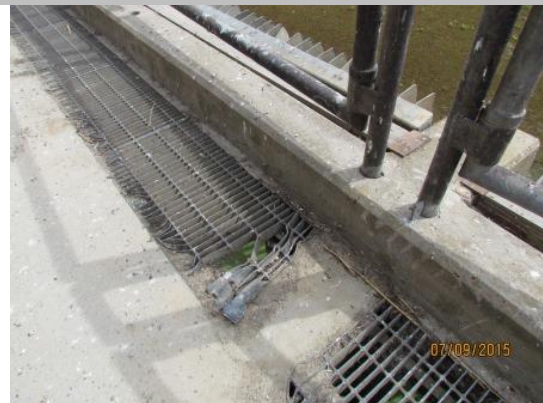
Photo 1 of 1 : ST_2015_NA0060_22_18_20150720_00027.jpg

Another view of the damaged grate.

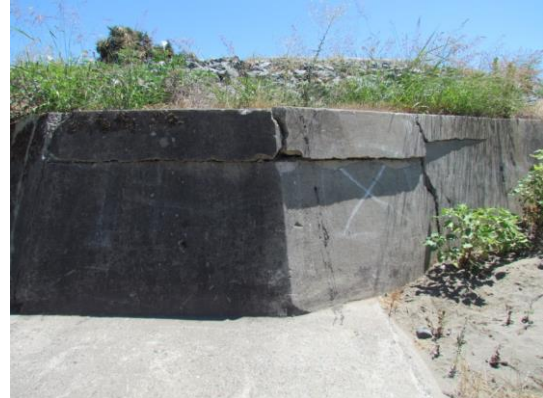
Photo 3 of 6 : ST_2015_NA0060_3_1_20150528_00004.jpg

Concrete cracking along the south wing wall.

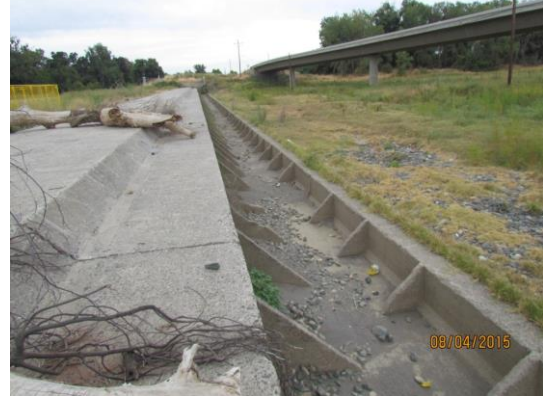
Photo 4 of 6 : ST_2015_NA0060_3_1_20150805_00014.jpg

View of some debris found on the structure.

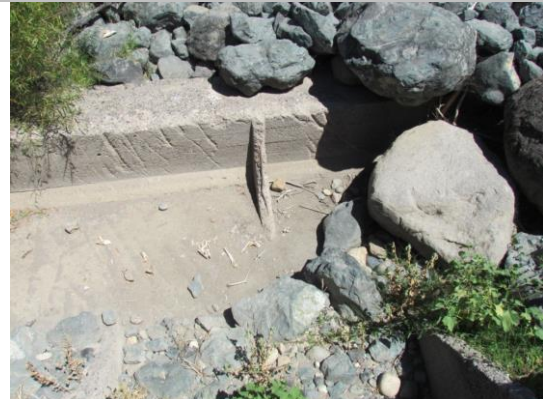
Photo 6 of 6 : ST_2015_NA0060_3_1_20150528_00006.jpg

Exposed rebar within the structure.

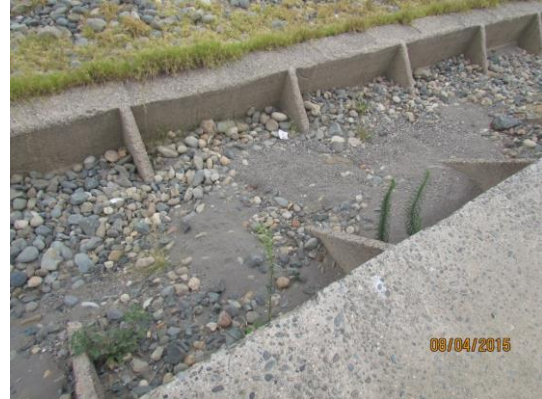
Photo 2 of 2 : x_2015_NA0060_3_3_20150820_00018.jpg

View of the sediment buildup in the weir.

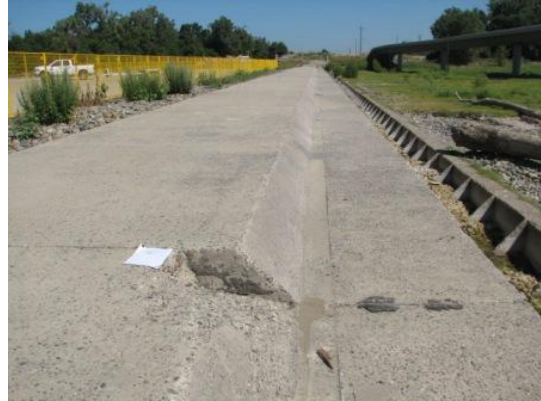
Photo 1 of 3 : ST_2015_NA0060_3_15_20150528_00008.jpg

This photo shows some surface damage.

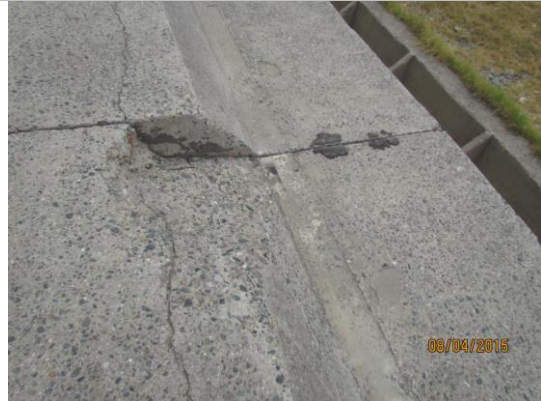
Photo 2 of 3 : ST_2015_NA0060_3_15_20150805_00009.jpg

View of some cracking on the weir.

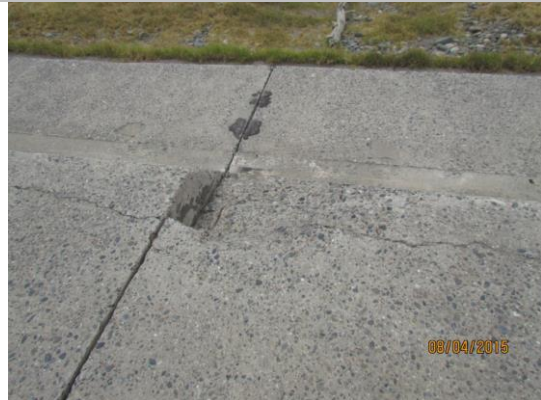
Photo 3 of 3 : ST_2015_NA0060_3_15_20150805_00010.jpg

Another view of the damaged area. Rebar can be observed.
